# Case Study: Pocatello

As seen in Land and Water Magazine  
Issue January/February 2013

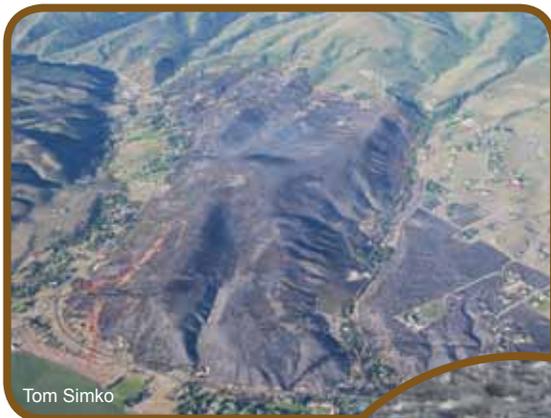
*Wildfire ravages through the neighborhoods of the hills above Pocatello, Idaho. Over 1,000 people were under mandatory evacuation orders. Approximately 1,038 acres of land was consumed in a little over 4 hours, destroying 66 homes and 29 outbuildings.*

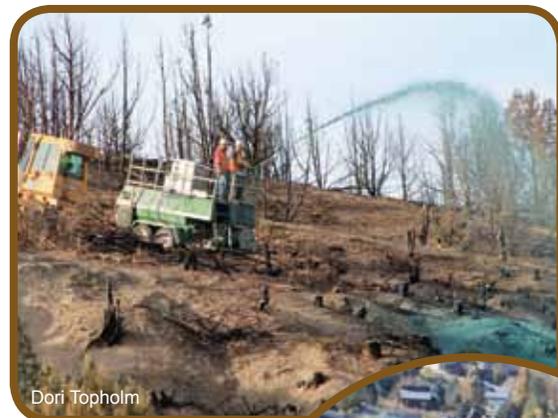
*Two application teams worked sun up to sun down for about three weeks to complete the massive job of applying hydromulch slurry to approximately 350 acres of steep terrain in need of extreme remediation.*

One of the contractors was Anderson Hydroseeding, locally owned and operated by brothers, Todd and Noel Anderson since 1995. They utilized their 900 gallon tow behind trailer to get into every nook and cranny in the locations that they were contracted to spray. The 40 HP Isuzu motor pumped the slurry out at about 65 GPM and sprayed at a distance of up to 160 feet. Some of the areas that they were contracted to cover were on terrain steep enough that they employed the use of their trailer connected to a caterpillar and backed it down the slopes in order to apply the mulch slurry to the desired, hard to reach locations. The Anderson Hydroseeding crew worked sun up to sun down for roughly 10 days to complete their portion of the project.

A few days before Anderson had completed their portion of the contract, Apex Erosion Control, a contractor from Clarkston, Washington and a subcontractor, Selby Erosion Control from Newcastle, California brought in larger, more specialized equipment to spray the longer, steeper, and more expansive slopes. Three of their finest application trucks between them, ranging from 4,000 to 5,000 gallon capacity, were onsite for approximately 8 days and together covered around 350 acres. The smaller of the two Apex trucks was a 5600I International truck with a 525 HP Cummins diesel motor that housed a 23,000 pound front end, a 46,000 pound rear end, six wheel drive; all lockers, and carried a massive 4,000 gallon Apex Xtreme hydro seeder with a 220 HP Deutz motor that was capable of discharging 300-400 feet. The larger truck was a Kenworth T800 with a 650 horsepower Cummins Diesel motor. This particular truck had a 22,000 pound front end and a 78,000 pound rear end with triple drive axles and triple lockers. It too had an Apex Xtreme hydro seeder but was a bit larger with 5,000 gallon capacity of slurry and had a 275 HP John Deere motor that gave it the power to also shoot 300-400 feet. Selby Erosion Control's bright yellow cab on their 357 Peak Peterbilt with a 350 HP Cummins Diesel was easy to spot on the slopes and fit in with the Apex pack with its 4,000 gallon Apex Xtreme hydro seeder with 180 HP Deutz engine that pushed the slurry out at a distance of up to 300 feet. All three trucks

were able to pump the slurry out at 1,000 GPM and apply 85,000 pounds of mulch per day.

The mulch that was used during the remediation varied from a Stabilized Mulch Matrix (SMM) to a Bonded Fiber Matrix (BFM) depending on the degree and length of the slopes, severity of the damage, and access to the spray locations. The slurry was made up of one of two mulches, Triple Tac™ tackifier, a seed mixture made up of wheatgrass, alfalfa and flax, and water in applications

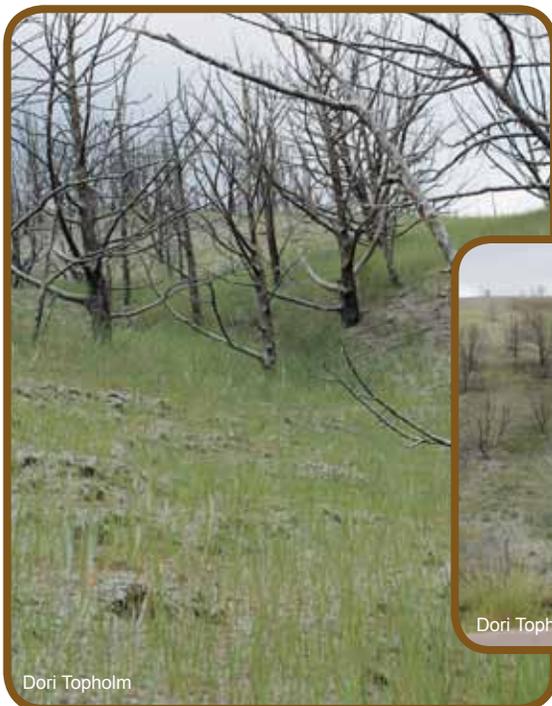
*Significant growth on steep slopes, one year after the fire and 8 months after application*

Just two days after the application was complete, a snowstorm covered the entire application area with several inches of snow. The location is to be monitored visually by representatives of the NRCS in the months and years following the application. As of December 5th, warmer winter weather has melted most of the snow that fell in the month earlier to reveal continuous coverage of the burned land with sprigs of seedlings already protruding through the mulch. It is the best outcome the team could have hoped for and they can’t wait to see what the hills will look like in the spring.
